# ***Premier Inspectors of America, Inc.***

**Inspection Number:** 450628051600  
**Inspection Date:** 06/28/05  
**Inspection Performed for:** Lisa & Robert Pageler  
**Property Address:** 56 West Willetta Street  
Phoenix , AZ

Premier Inspectors of America, Inc - Inspection # 450628051600  
56 West Willetta Street - Phoenix , AZ  
[www.prelook.com](http://www.prelook.com) (888) 773-5665

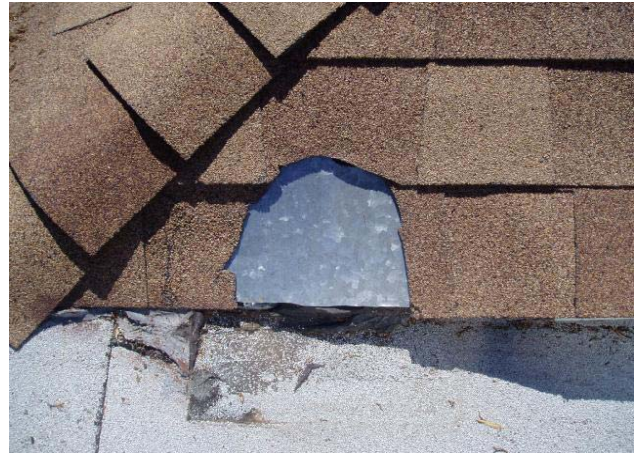
Patching on the rear roof line

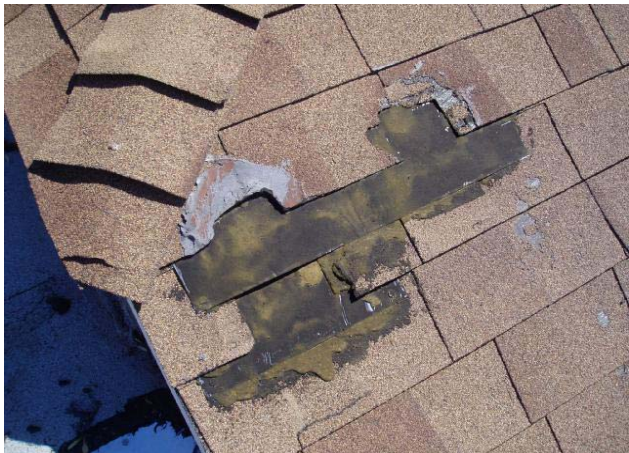
Patching observed on the rear portion of the roof line

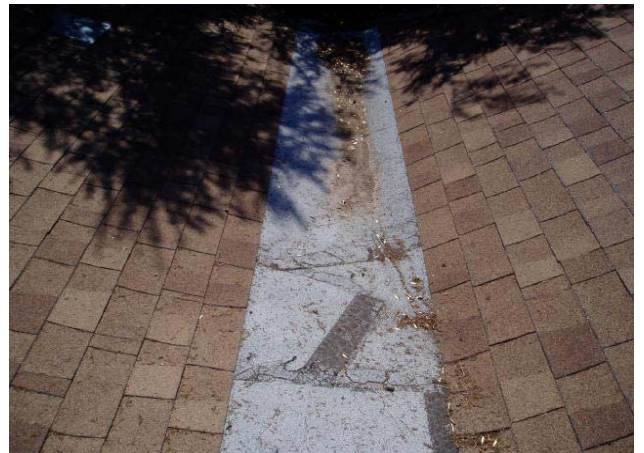
Shingle Roof Line & Roofing Systems (debris in the valleys)

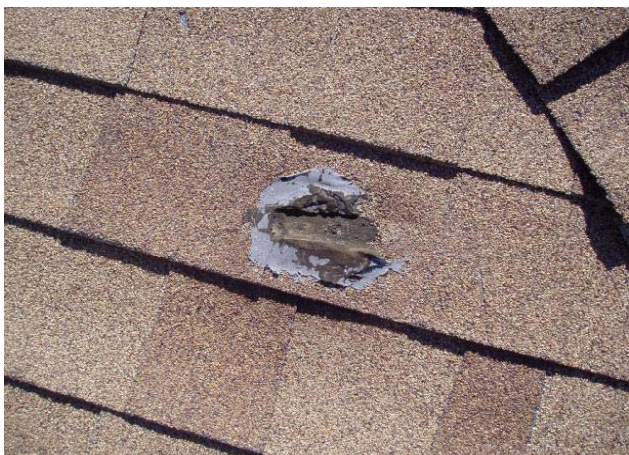
Patching on the rear roof line

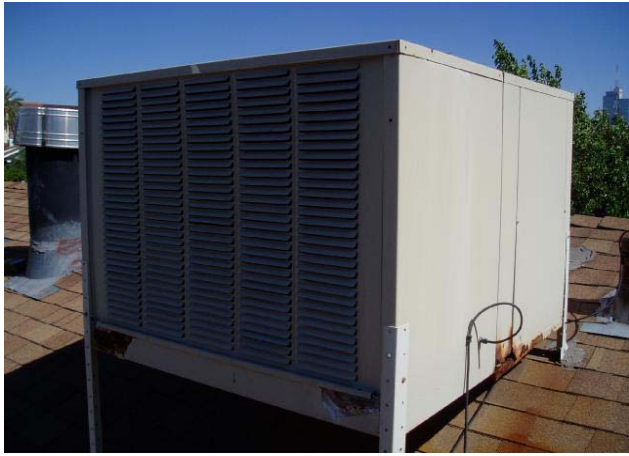
Because the water for the evaporative coolers was off we are unable to test these systems, these item was not tested at the time of the inspection. Suggest verification of working condition be made by the seller. Corrosion observed on the casing of the upper unit. Corrosion observed on the supports of the upper unit. Suggest replacing the fan belt for more efficient operation. Suggest extending the drain line to the edge of the roof. Suggest cleaning the water pads for more effecient operation. The Evap cooler on the upper roof line appears to be at the end of its useful life.

Evap-Cooler over the front portion of the home (inop)

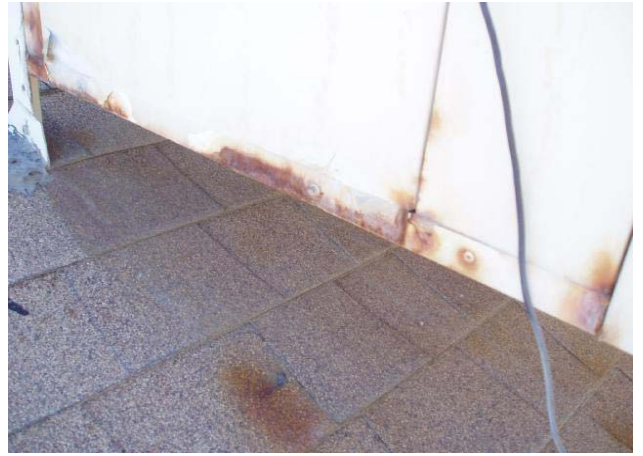
Evap-Cooler over the front portion of the home (inop)

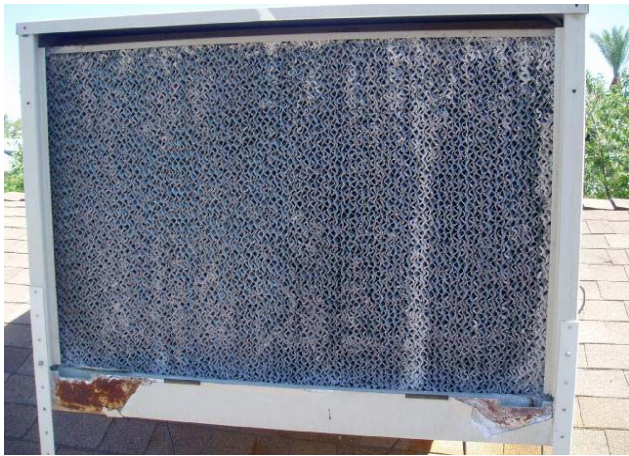
Evap-Cooler over the front portion of the home (inop)

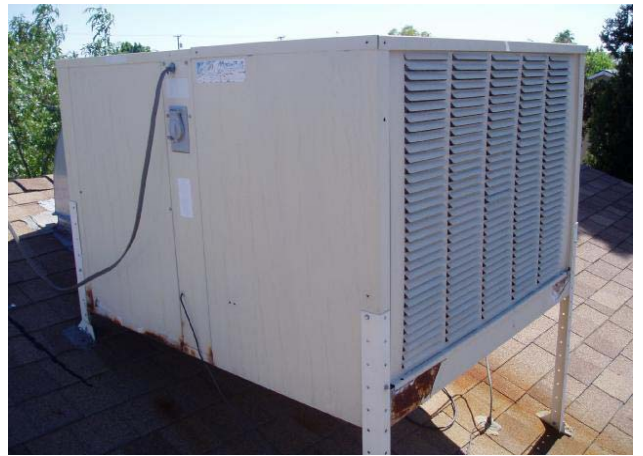
Evap-Cooler over the front portion of the home (inop)

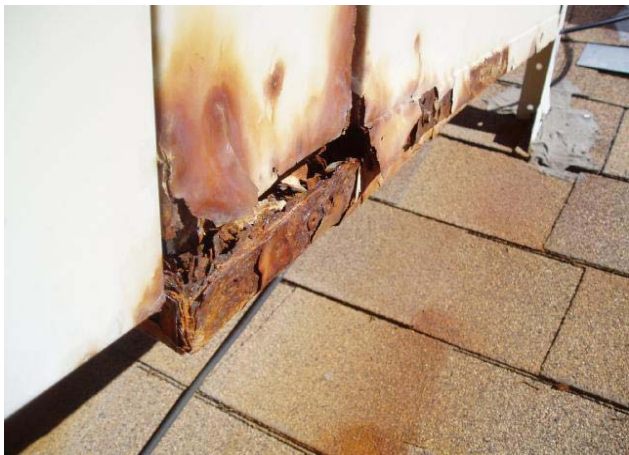
Evap-Cooler over the front portion of the home (inop)

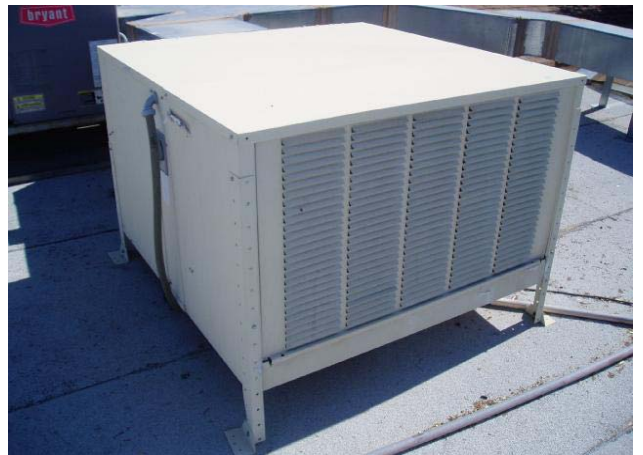
Rear addition Evap-Cooler (inop)

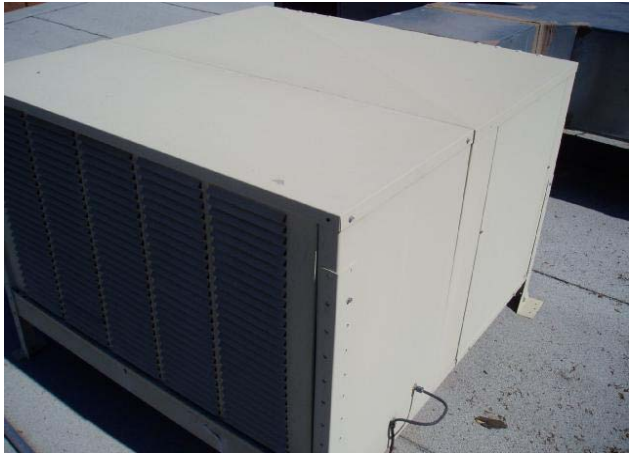
Rear addition Evap-Cooler (inop)

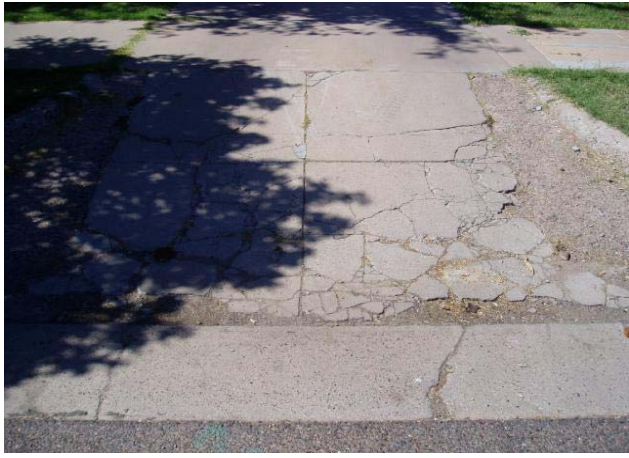
<b>Driveway</b>	Concrete, common cracks observed.
<b>Walks</b>	Concrete, common cracks observed.
<b>Street Walkway</b>	Concrete, common cracks observed. Deterioration present. Suggest monitoring this as future repairs/replacement may be necessary.

Deterioration on the front approach

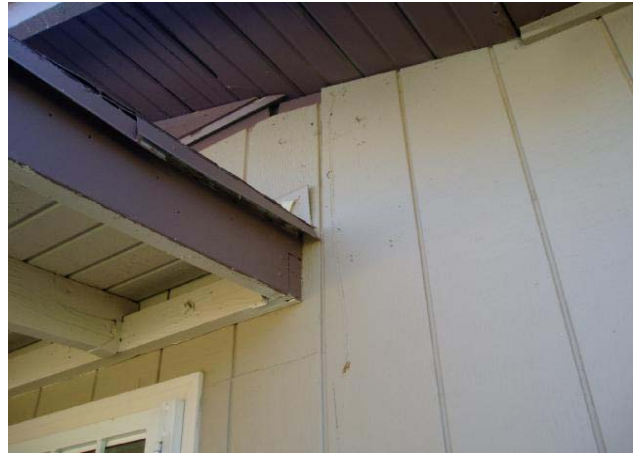
Suggest kick out flashings

<b>Flashing</b>	Suggest caulking around the penetrations through the roof to prevent water from entering the building. Suggest adding kick out flashing where the roof meets the side wall of the structure to prevent water from getting behind the siding material. Suggest monitoring this as future repairs/replacement may be necessary.
<b>Valleys</b>	Closed (covered by a layer of shingles,) Due to the construction of the valley we are unable to determine if metal flashing has been installed under the shingles. Suggest removing the debris from the roof valleys to prevent water retention which will lead to increased deterioration of the roofing materials.
<b>Chimney</b>	Stove pipe, spark arrestor present. This item will prevent water and pest entry and keep sparks from exiting the chimney. Suggest installing three screws per connection of the fireplace cap for safety. Because the majority of the flue liner is not viewable it is excluded from the scope of our inspection. For this reason we suggest that a scan of the interior of the chimney liner be performed by a CSIA certified sweep prior to use.

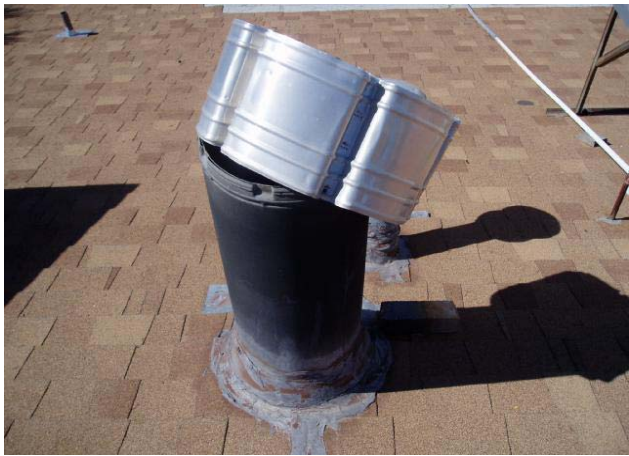
Loose Chimney Cap

Stove pipe, Spark arrestor present. This item will prevent water and pest entry and keep sparks from exiting the chimney. Suggest installing three screws per connection of the fireplace cap for safety. Because the majority of the flue liner is not viewable it is excluded from the scope of our inspection. For this reason we suggest that a scan of the interior of the chimney liner be performed by a CSIA certified sweep prior to use.

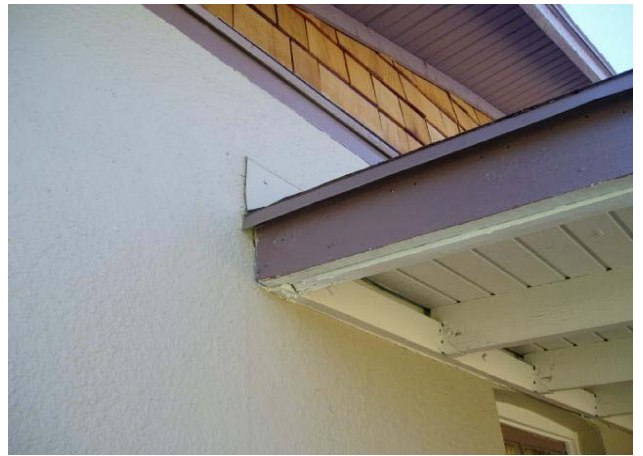
Suggest kick out flashings

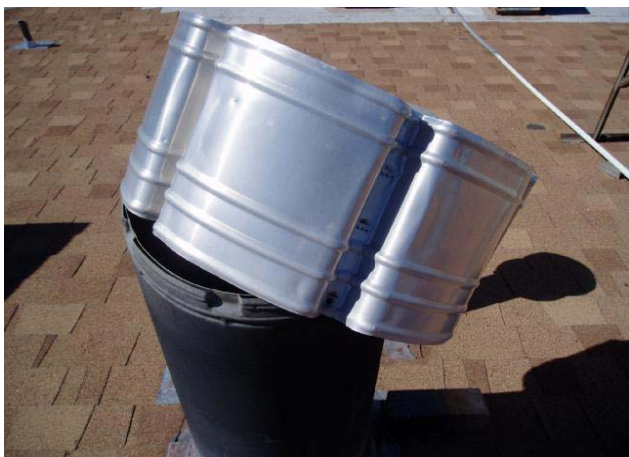
Loose Chimney Cap

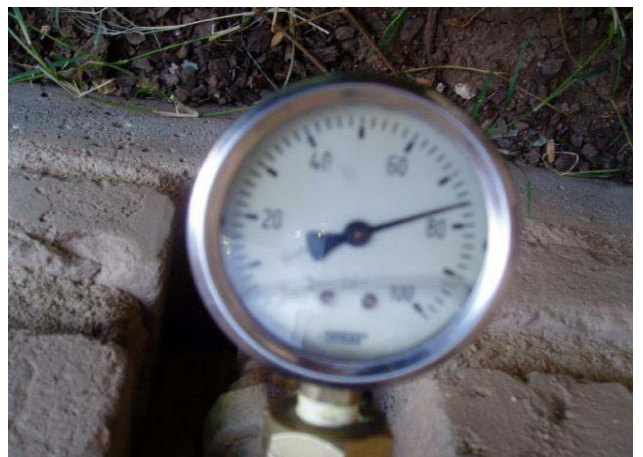
76 psi on the water dist.

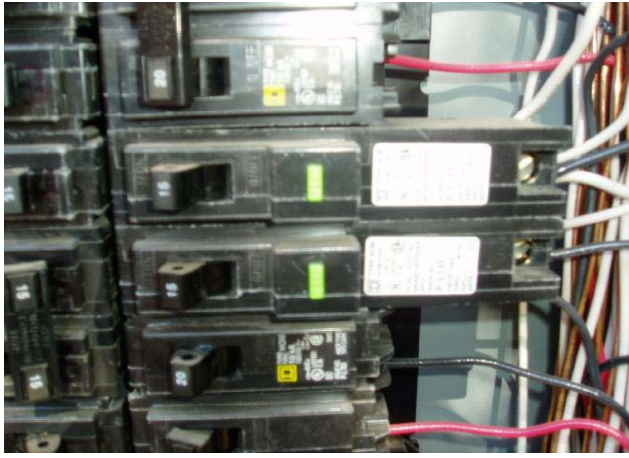
200 Amp. Electrical Main Breaker Panel (arch faults)

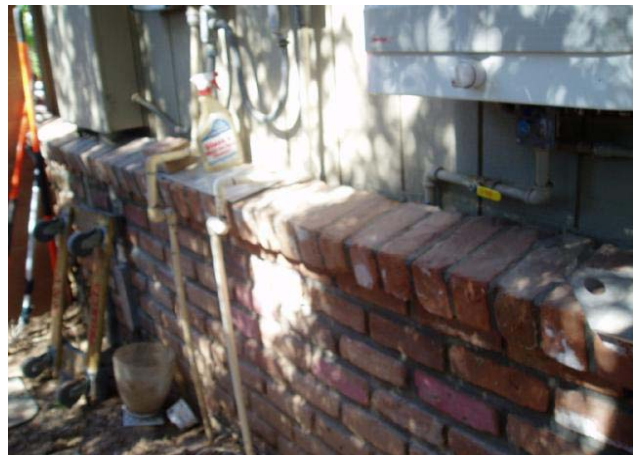
Loose brick and missing flashing

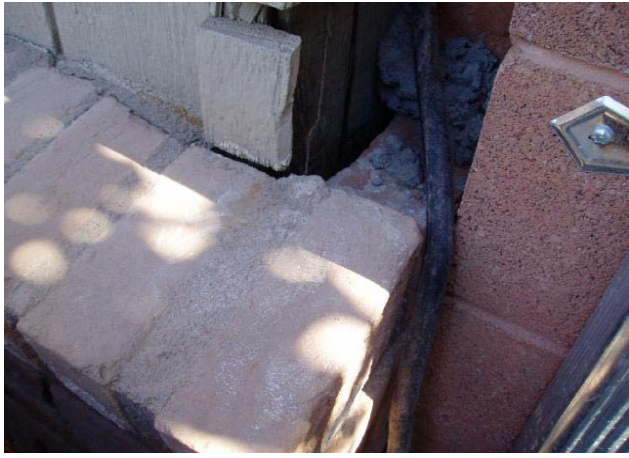
Loose brick and missing flashing

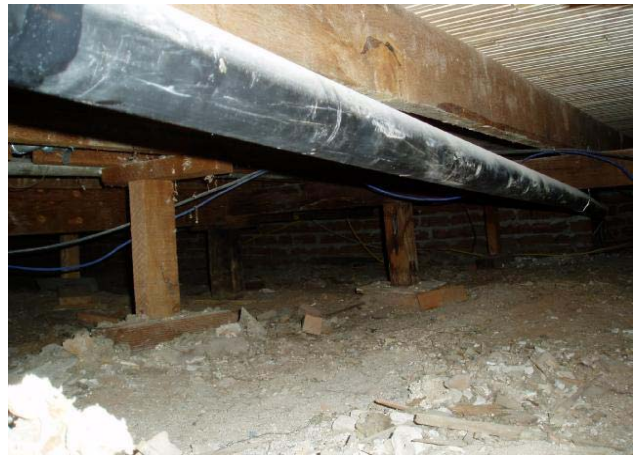
Needs plumbing supports

**General Piping** Copper, galvanized, plastic (wisbo) Suggest adding support to the pipes to prevent sagging and possible breakage under the crawlspace.

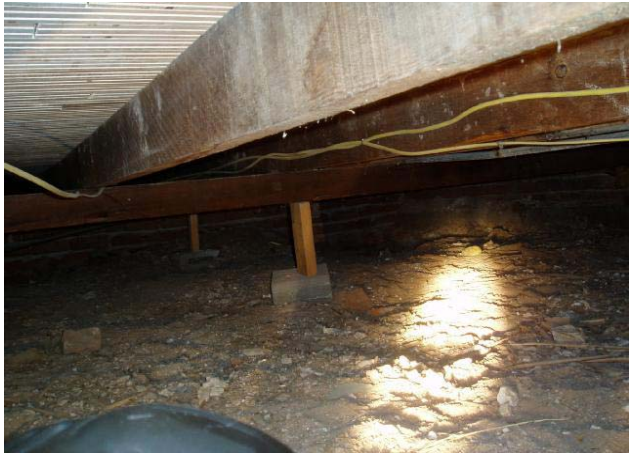
Suggest more flooring supports

**Support post(s)** Wood, concrete piers, suggest securing the supporting members to the framing above it.

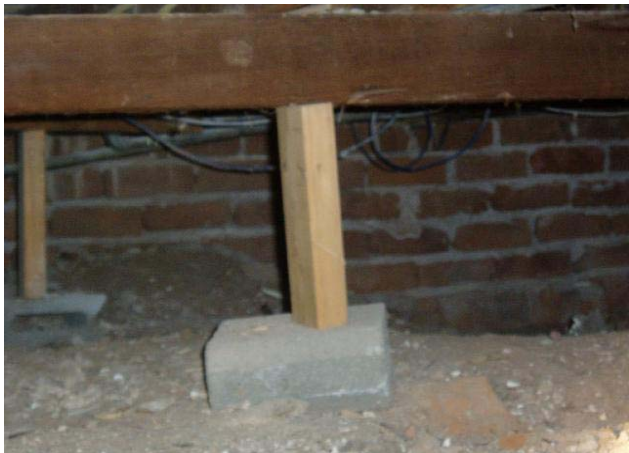
Suggest more flooring supports (leaning)

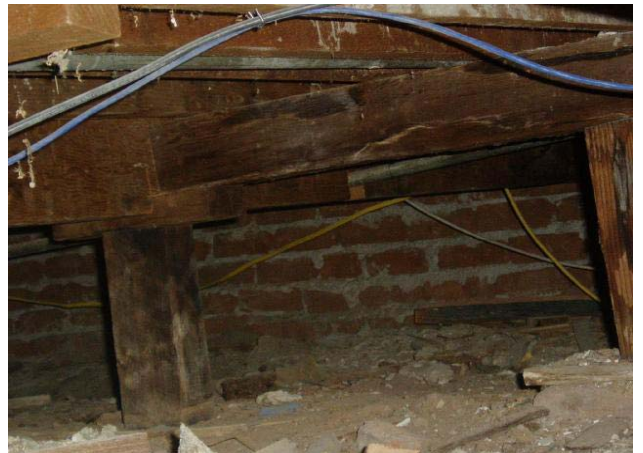
Suggest more flooring supports

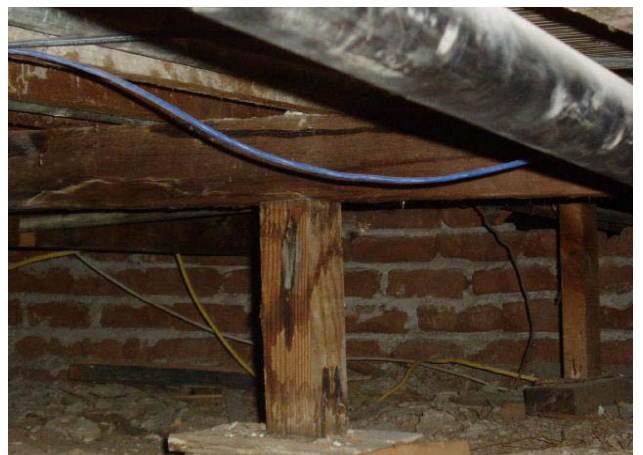
Suggest more flooring supports

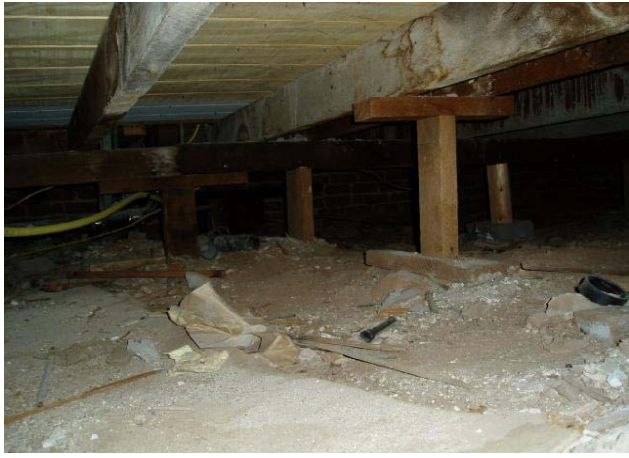
Suggest more flooring supports

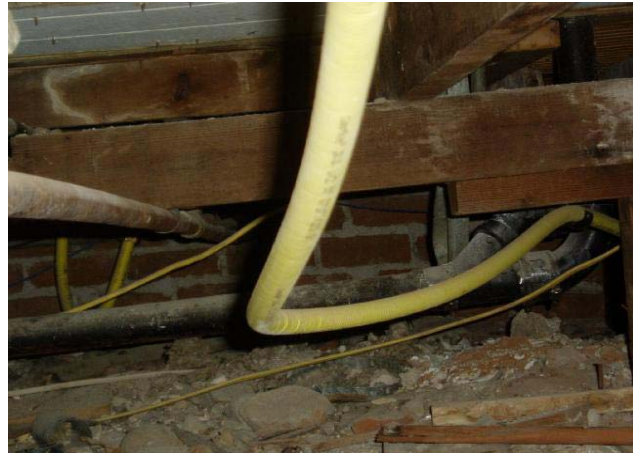
Need to support the gas and plumbing

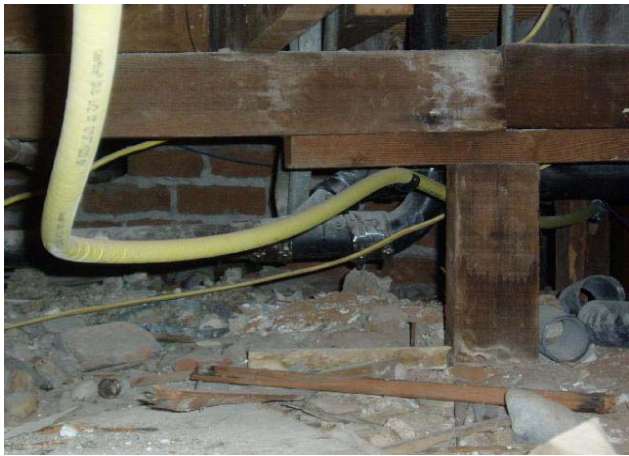
Suggest more flooring supports

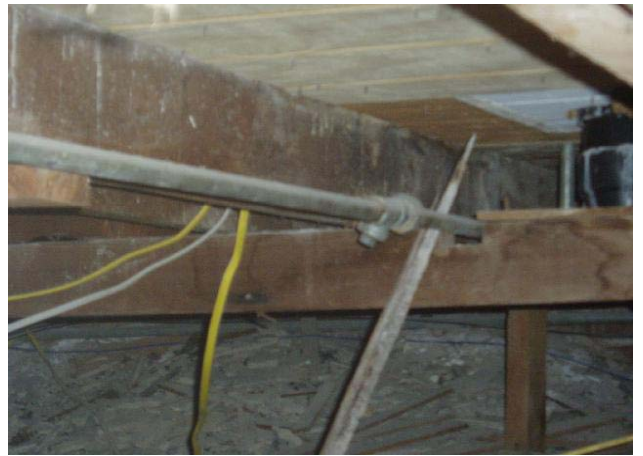
Need to support the gas and plumbing

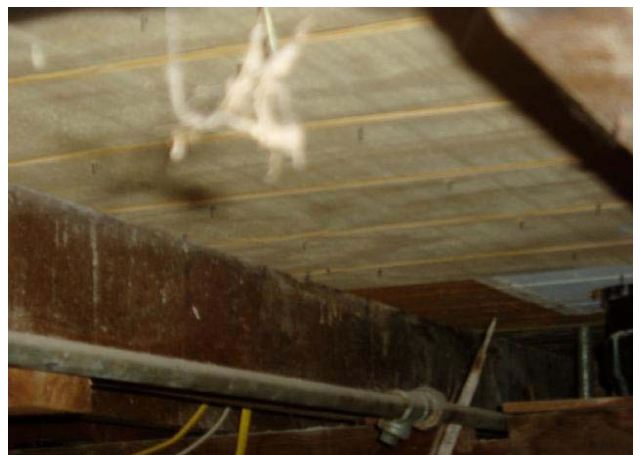
Need to support the gas and plumbing

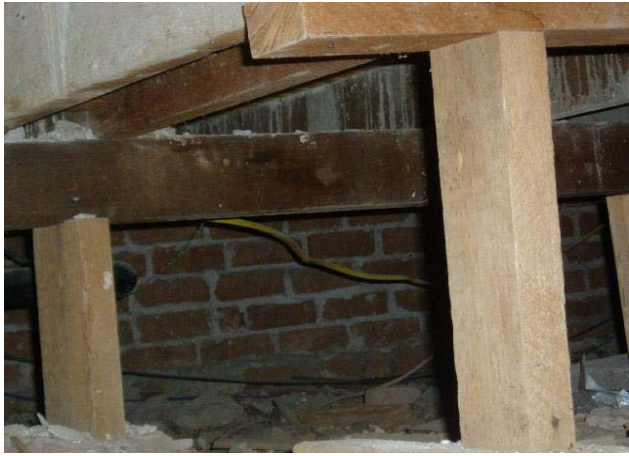
Adjust the floor supports

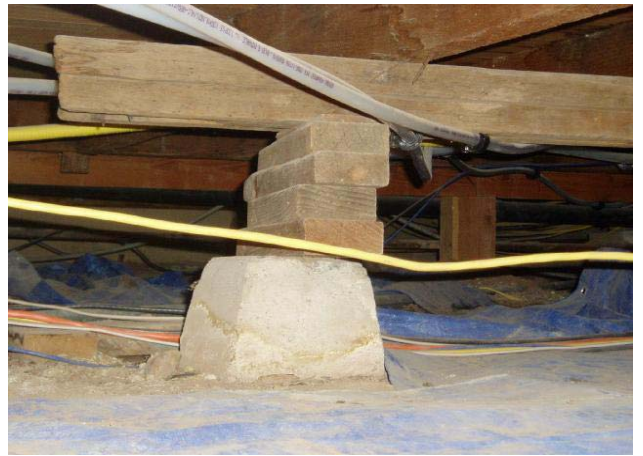
Need to adjust the supports

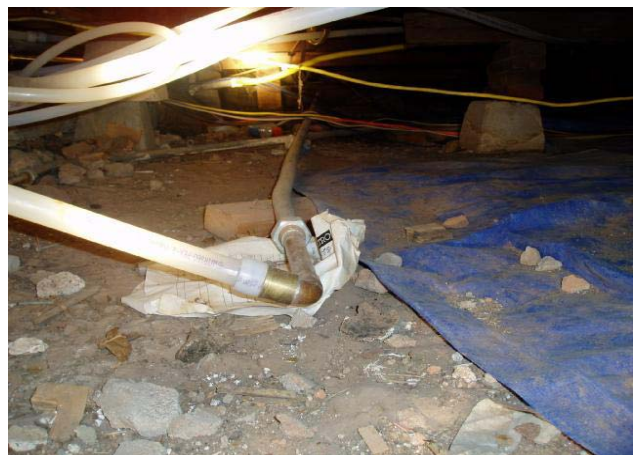
Need to support the plumbing

**Waste Piping** Sewage for the property appears to be handled by the city. Plastic pipes, cast iron, suggest adding support to the waste lines to prevent sagging or possible breakage.

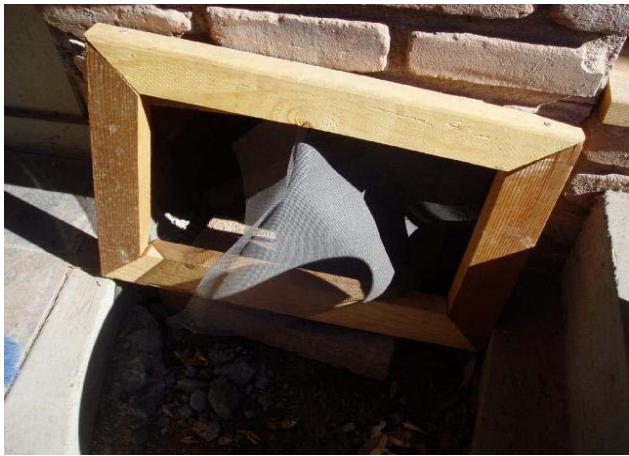
Need screens

Suggest installing screens over the ventilation holes.
