# ***Premier Inspectors of America, Inc.***

**Inspection Number:** 450731050900  
**Inspection Date:** 07/31/05  
**Inspection Performed for:** Lisa & Robert Pageler  
**Property Address:** 56 West Willetta Street  
Phoenix , AZ

## **A. SUMMARY**

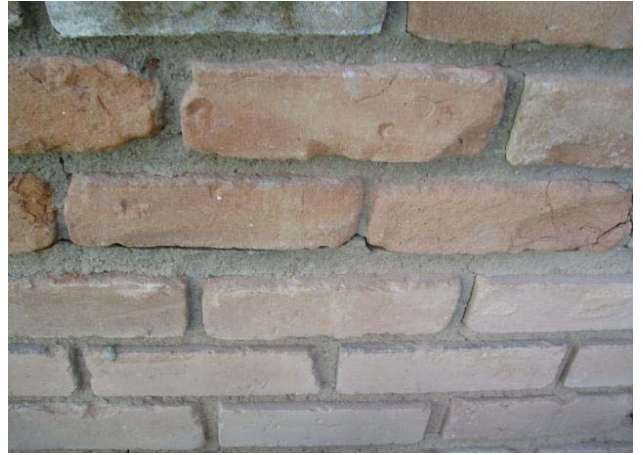
Brick siding

| <b>Siding</b> | Brick, suggest tuckpointing be done in the area(s) where deteriorated mortar is present. Suggest monitoring this as future repairs/replacement may be necessary. |

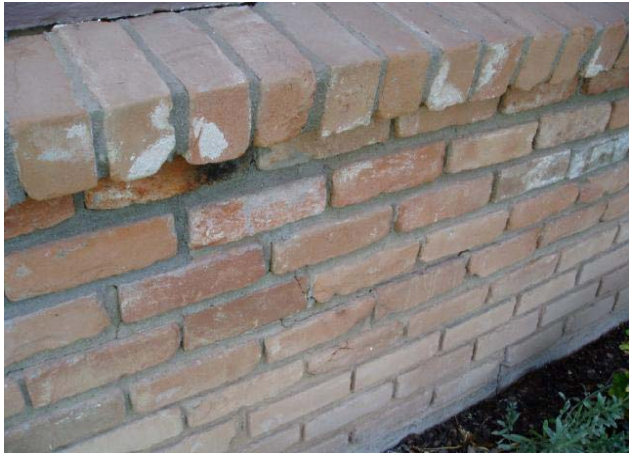
Brick siding

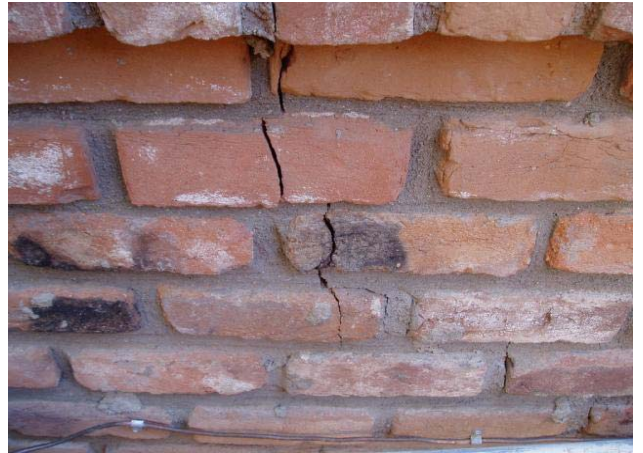
Brick siding

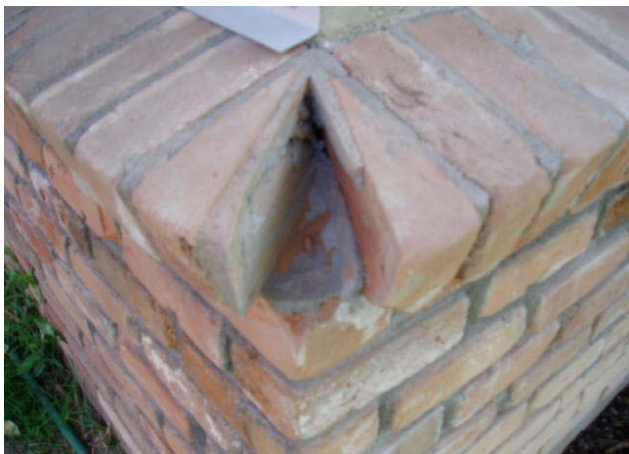
Brick siding

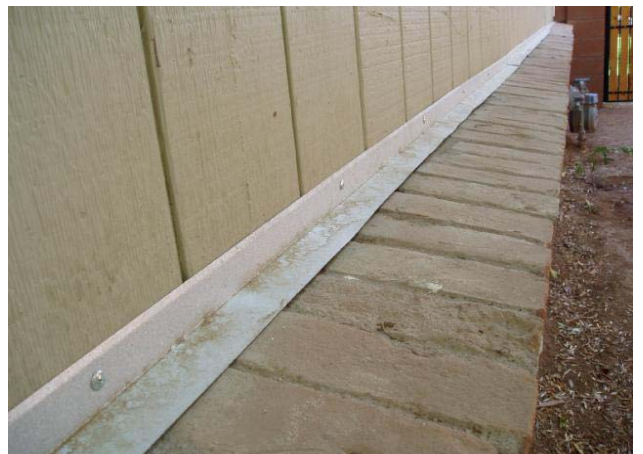
Brick siding and flashing

**Flashing**                      Suggest adding kick out flashing where the roof meets the side wall of the structure to prevent water from getting behind the siding material.

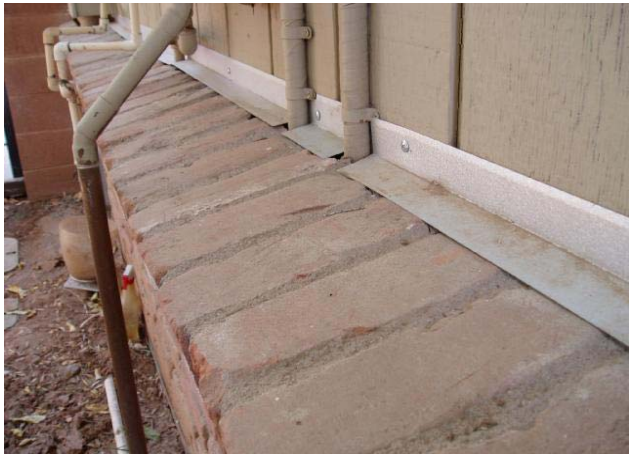
Brick siding and flashing

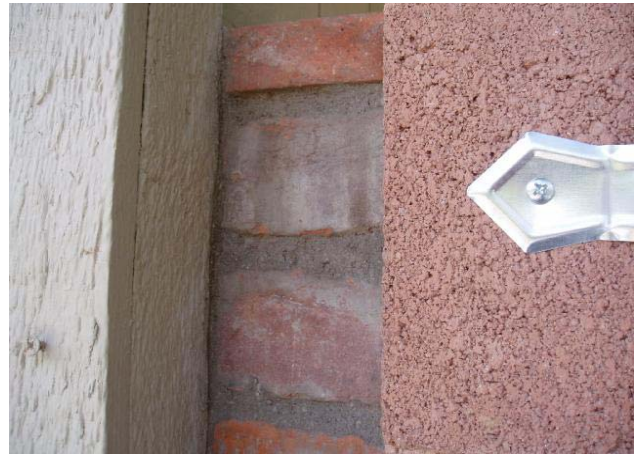
Brick siding and flashing

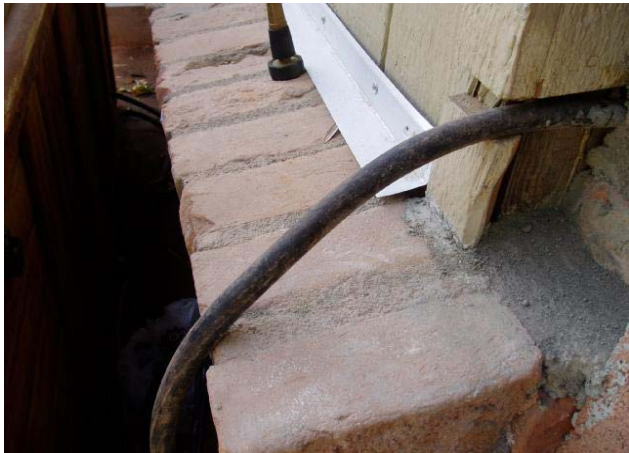
Brick siding and flashing

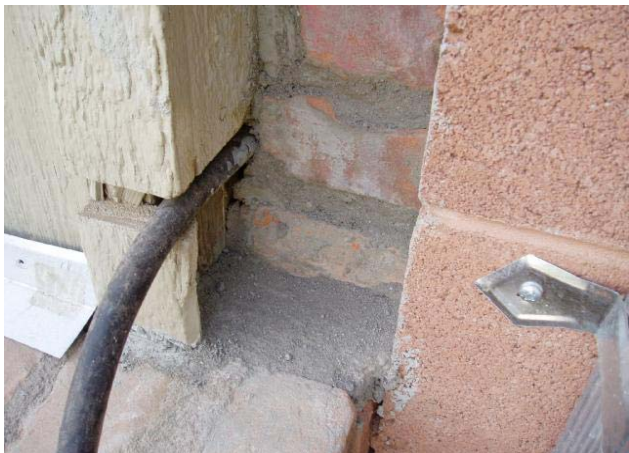
Brick siding and flashing

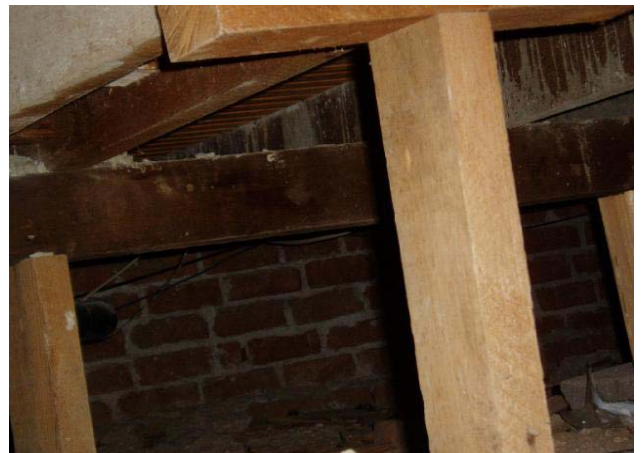
Supports for the flooring have been added

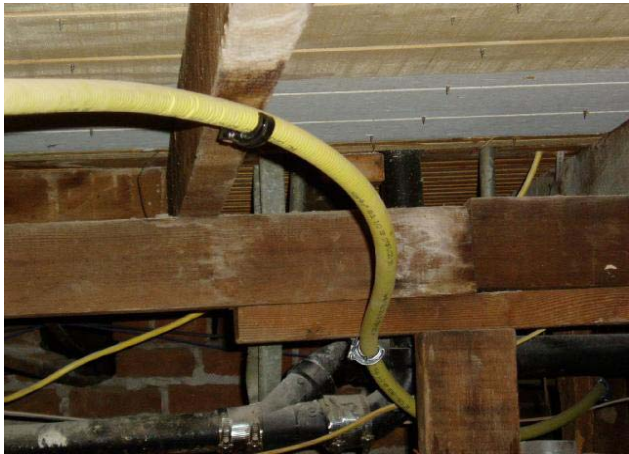
Supports for the flooring have been added

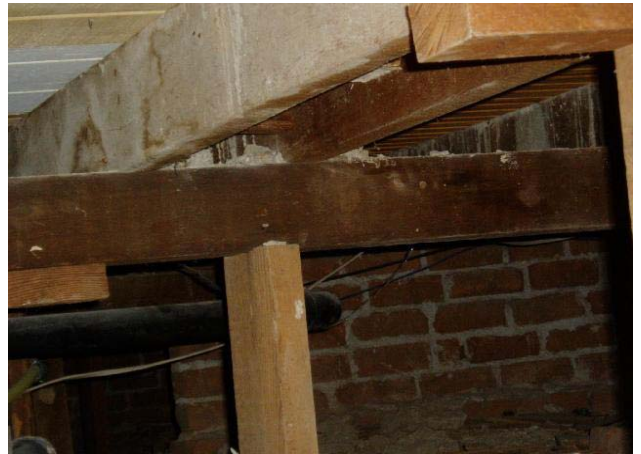
Supports for the flooring have been added

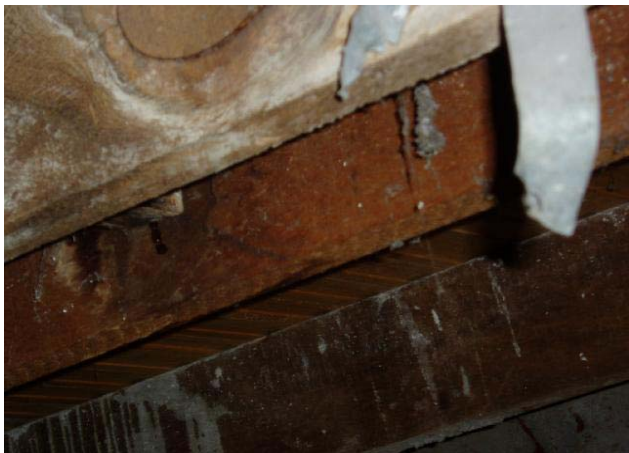
Supports for the flooring have been added

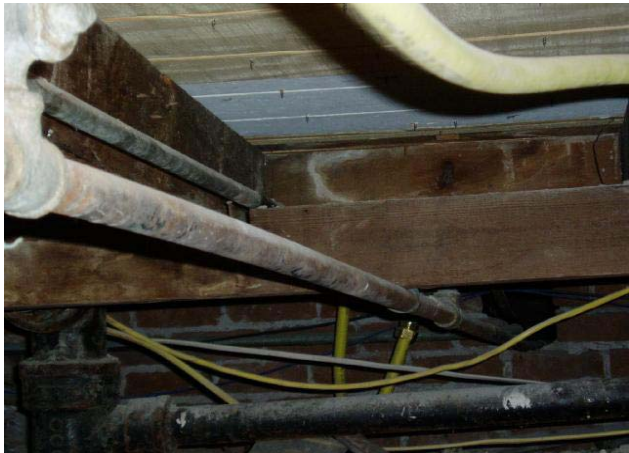
Supports for the flooring have been added

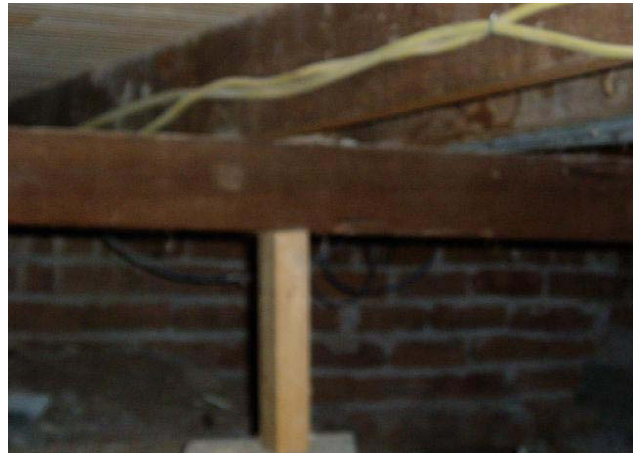
Supports for the flooring have been added

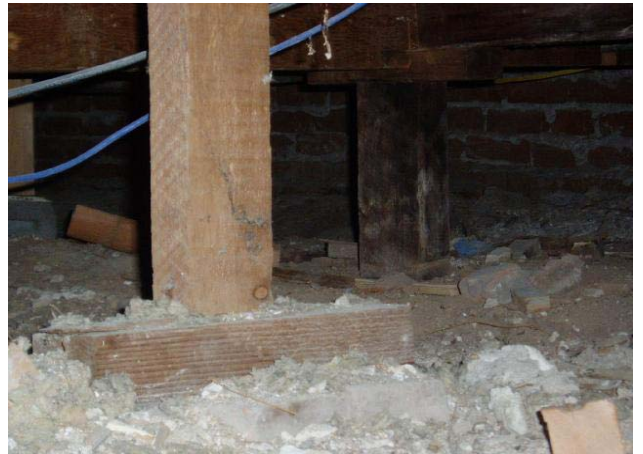
Supports for the flooring have been added

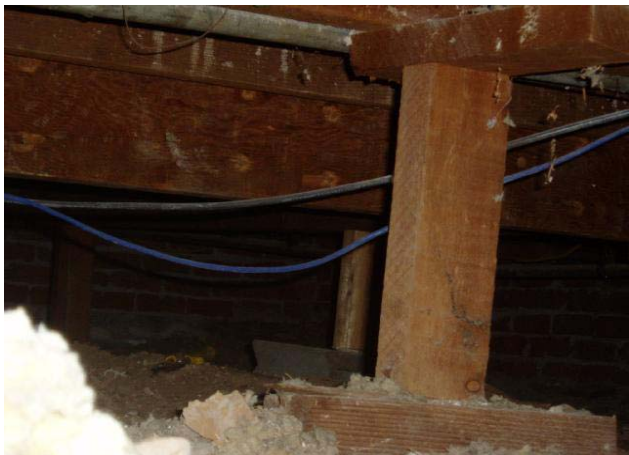
Supports for the flooring have been added

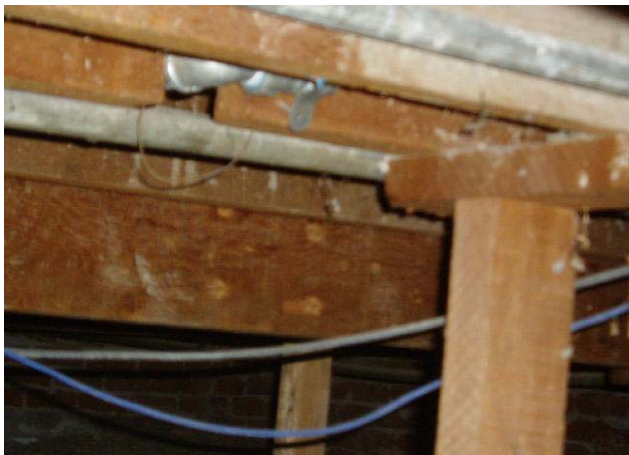
Supports for the flooring have been added

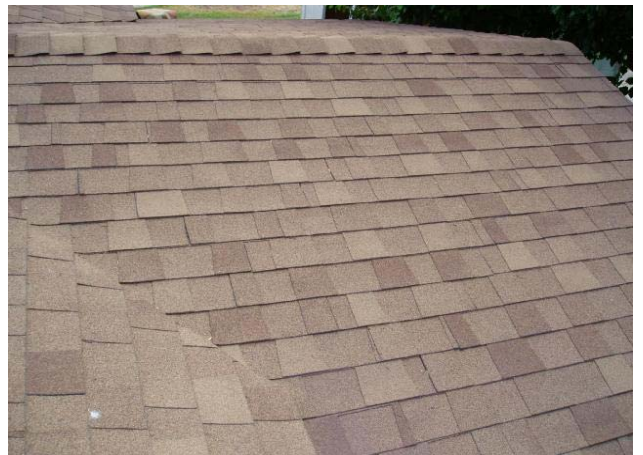
**Covering & Condition**      Composition shingle, this type shingle is composed of an asphalt impregnated mat covered with a granular aggregate. Sloped construction. Granular loss on the surface of the shingles noted. Areas of patching present. This may have been done due to a past roof leak. Suggest consultation with the seller for more information. The roof appears to be in the second third of its useful life. Periodic maintenance can allow for more years of usefulness. One layer of shingles observed.

Roof line and repairs

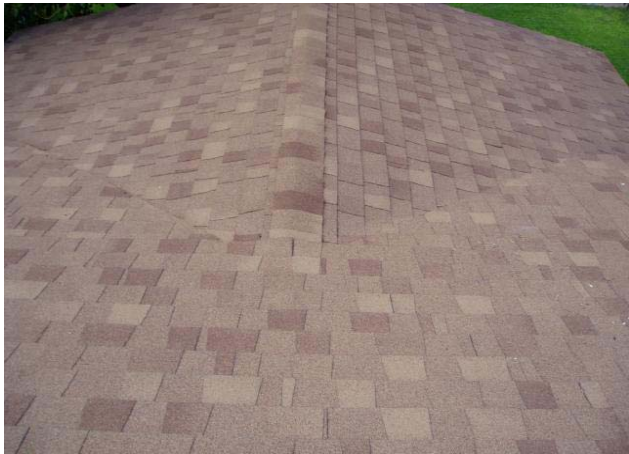
Roof line and repairs

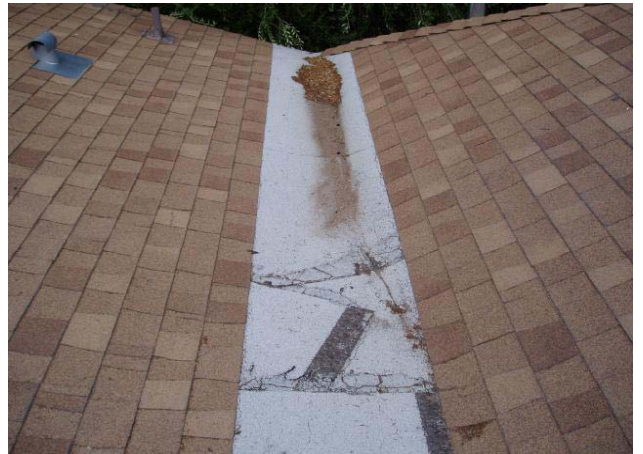
Roof line and repairs

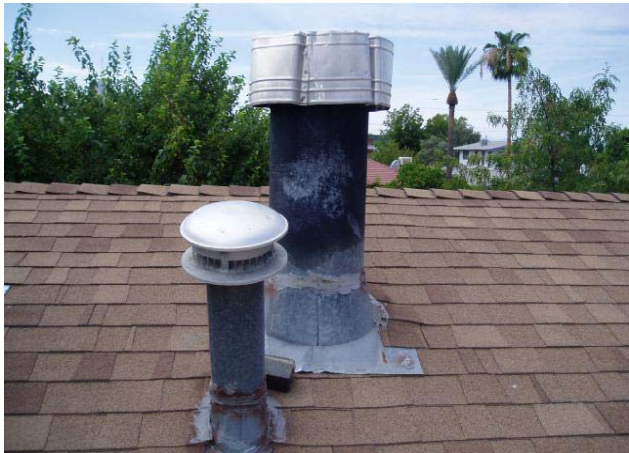
Roof line and repairs

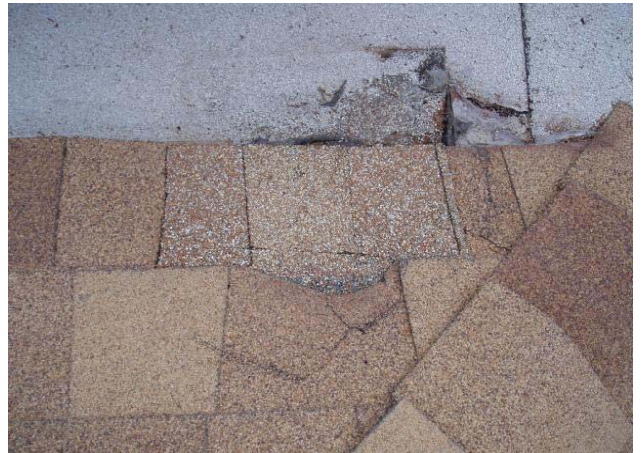
Roof line and repairs

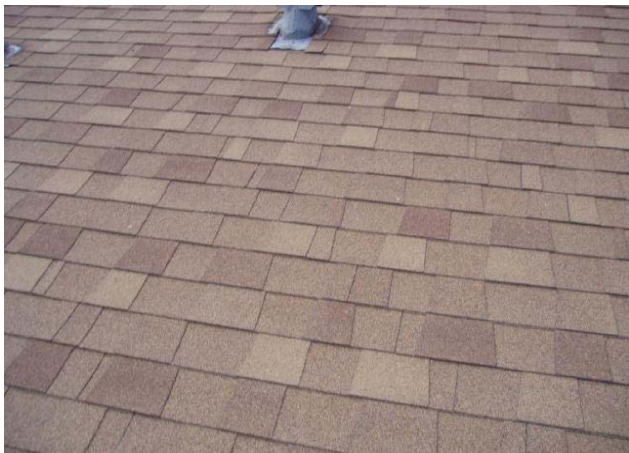
Roof line and repairs

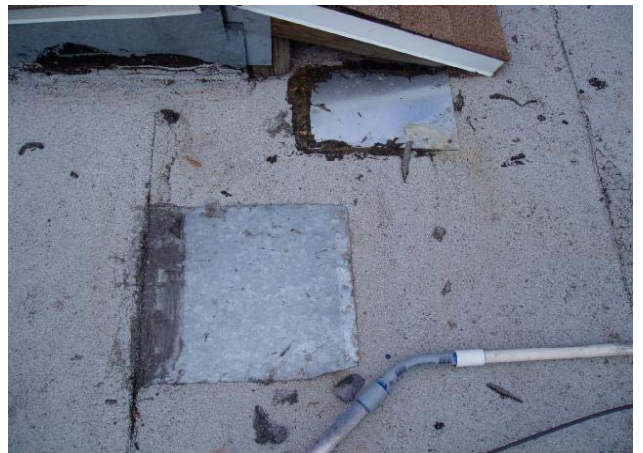
Roof line and repairs

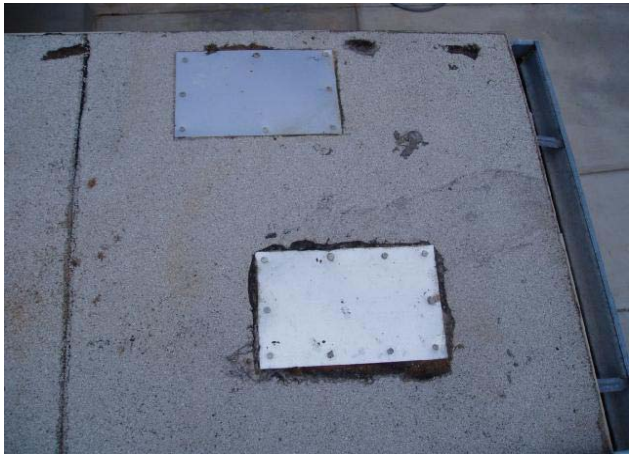
Roof line and repairs

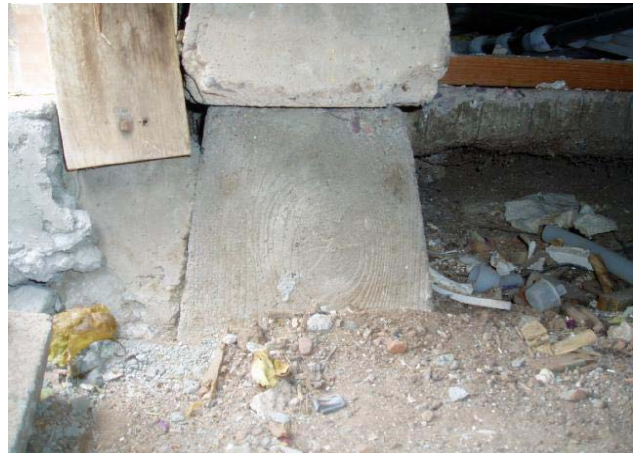
Supported piping
