# ***Premier Inspectors of America, Inc.***

**Inspection Number:** 450628051600  
**Inspection Date:** 06/28/05  
**Inspection Performed for:** Lisa & Robert Pageler  
**Property Address:** 56 West Willetta Street  
Phoenix , AZ

Premier Inspectors of America, Inc - Inspection # 450628051600  
56 West Willetta Street - Phoenix , AZ  
[www.prelook.com](http://www.prelook.com) (888) 773-5665

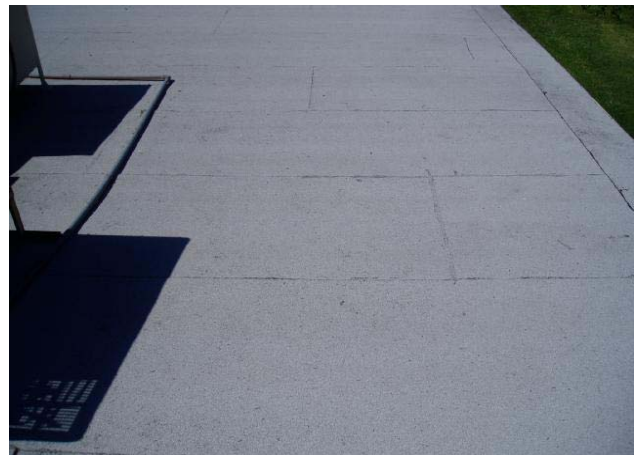
Rolled Roofing over the Rear Patio/Addition

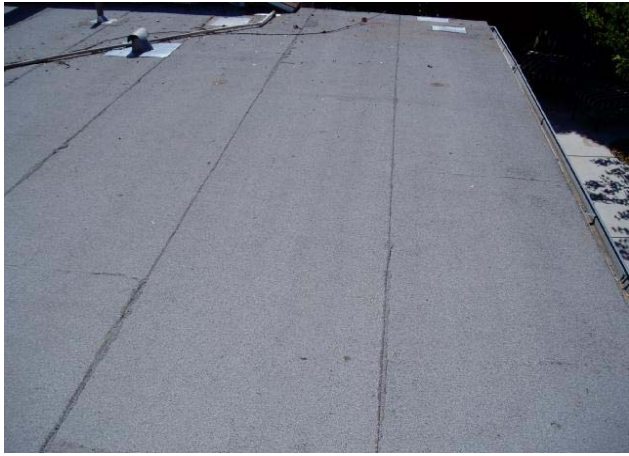
Rolled Roofing over the Rear Patio/Addition

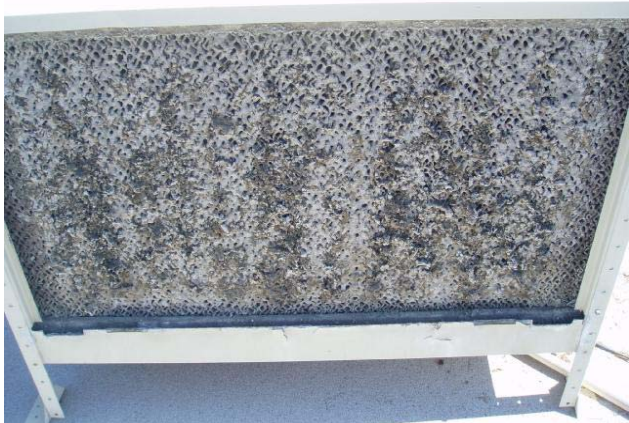
Rear addition Evap-Cooler (inop)

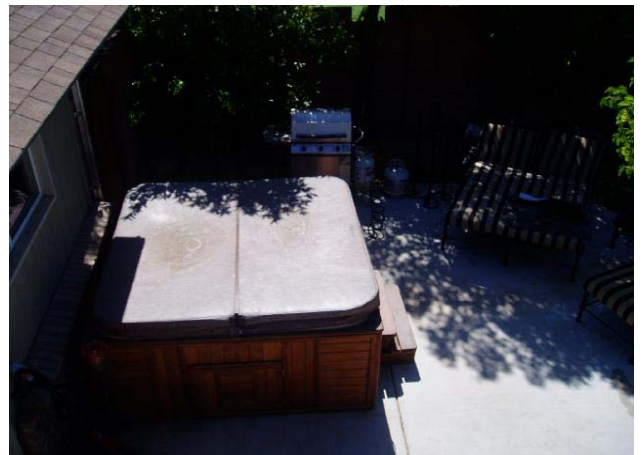
Spa not tested.

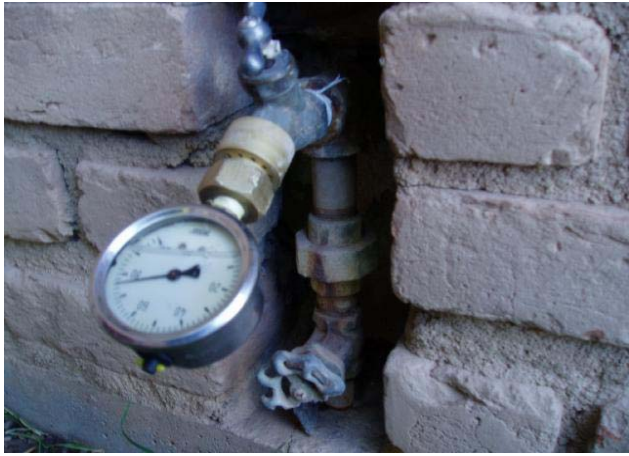
Water dist.

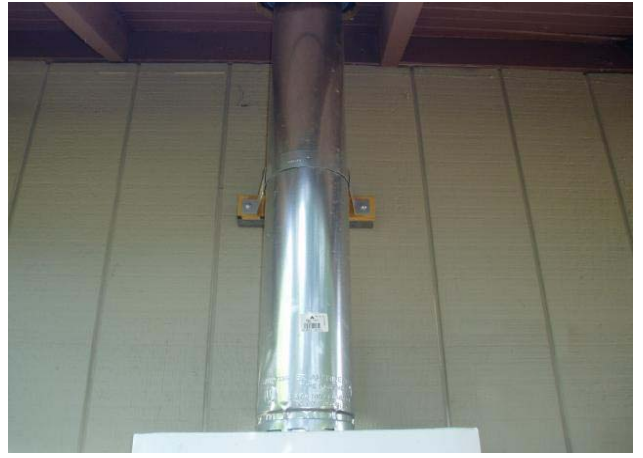
Tank less water heater connections (vent)

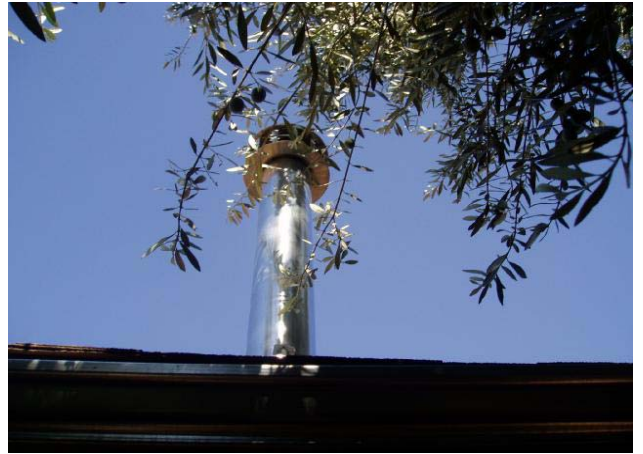
Tank less water heater connections (vent)

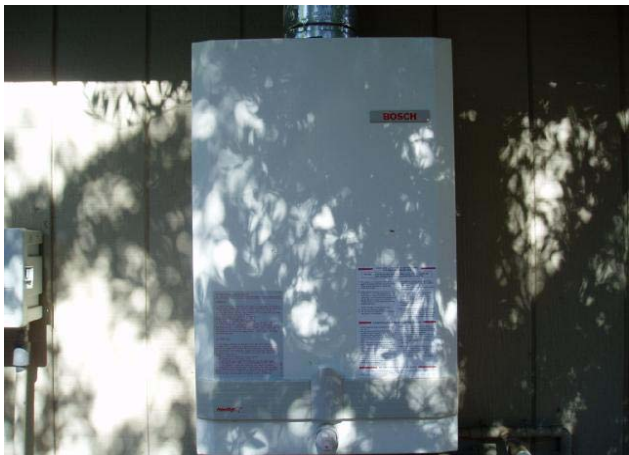
Tank less water heater connections

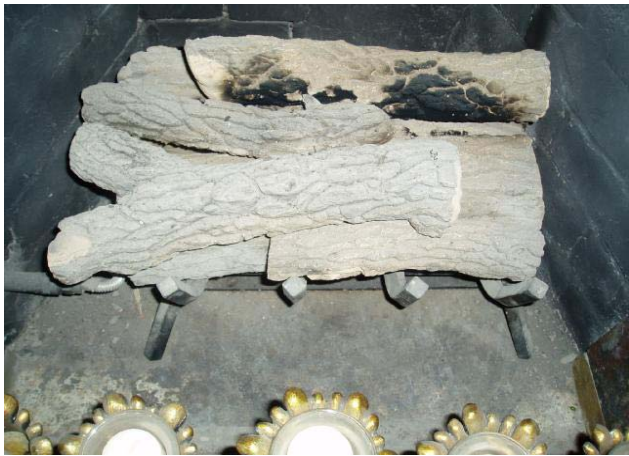
Gas fireplace operated

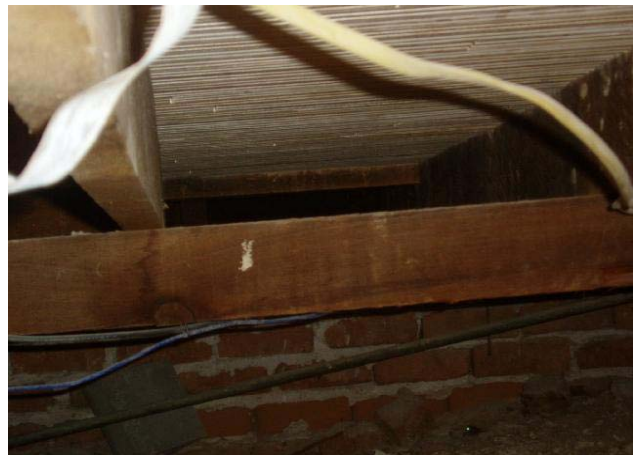
Floor supports

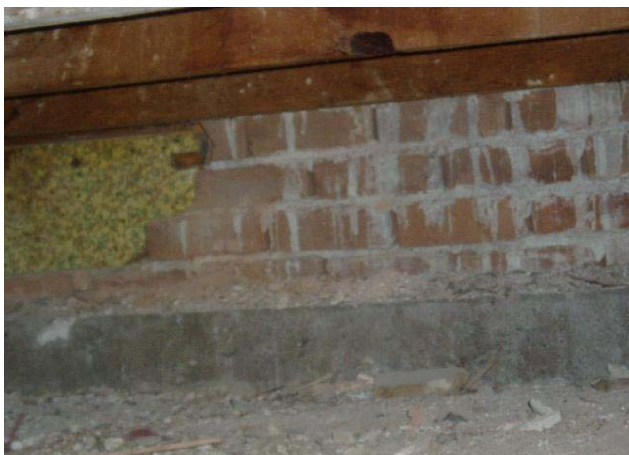
Suggest more flooring supports

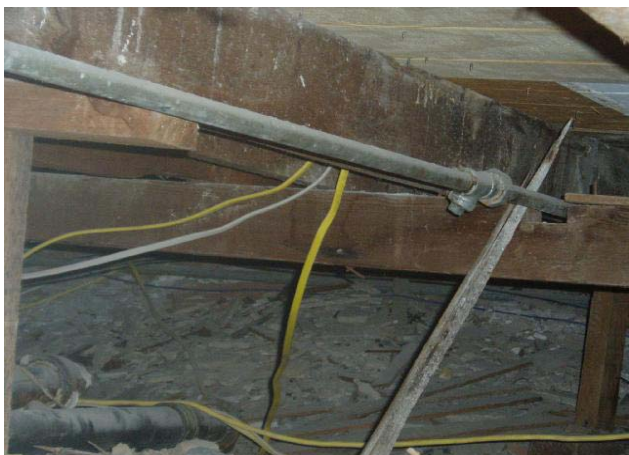
Need to support the gas and plumbing

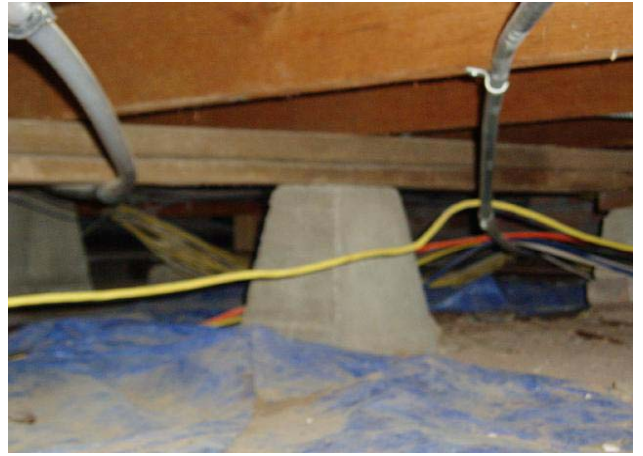
Adjust the floor supports

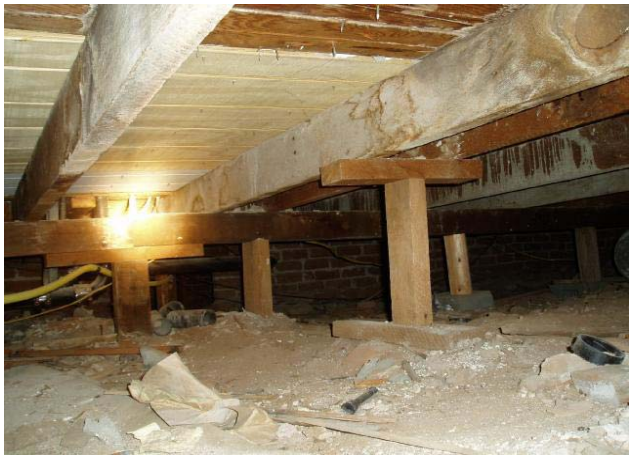
Proper supports

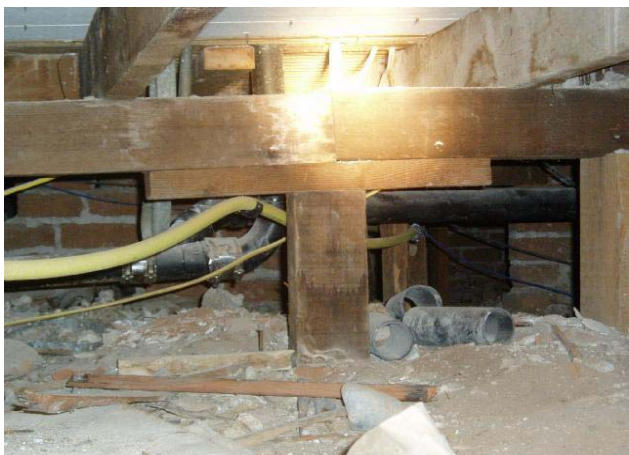
Need to adjust the supports

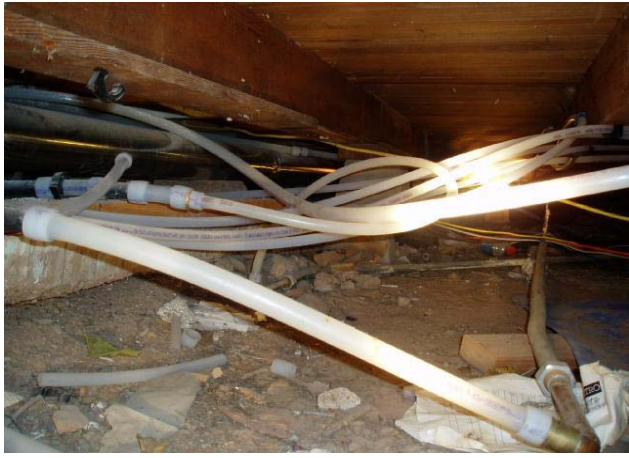
Need to support the plumbing
